2002 Annual Compliance Report Tuba City, Arizona, Disposal Site

Compliance Summary

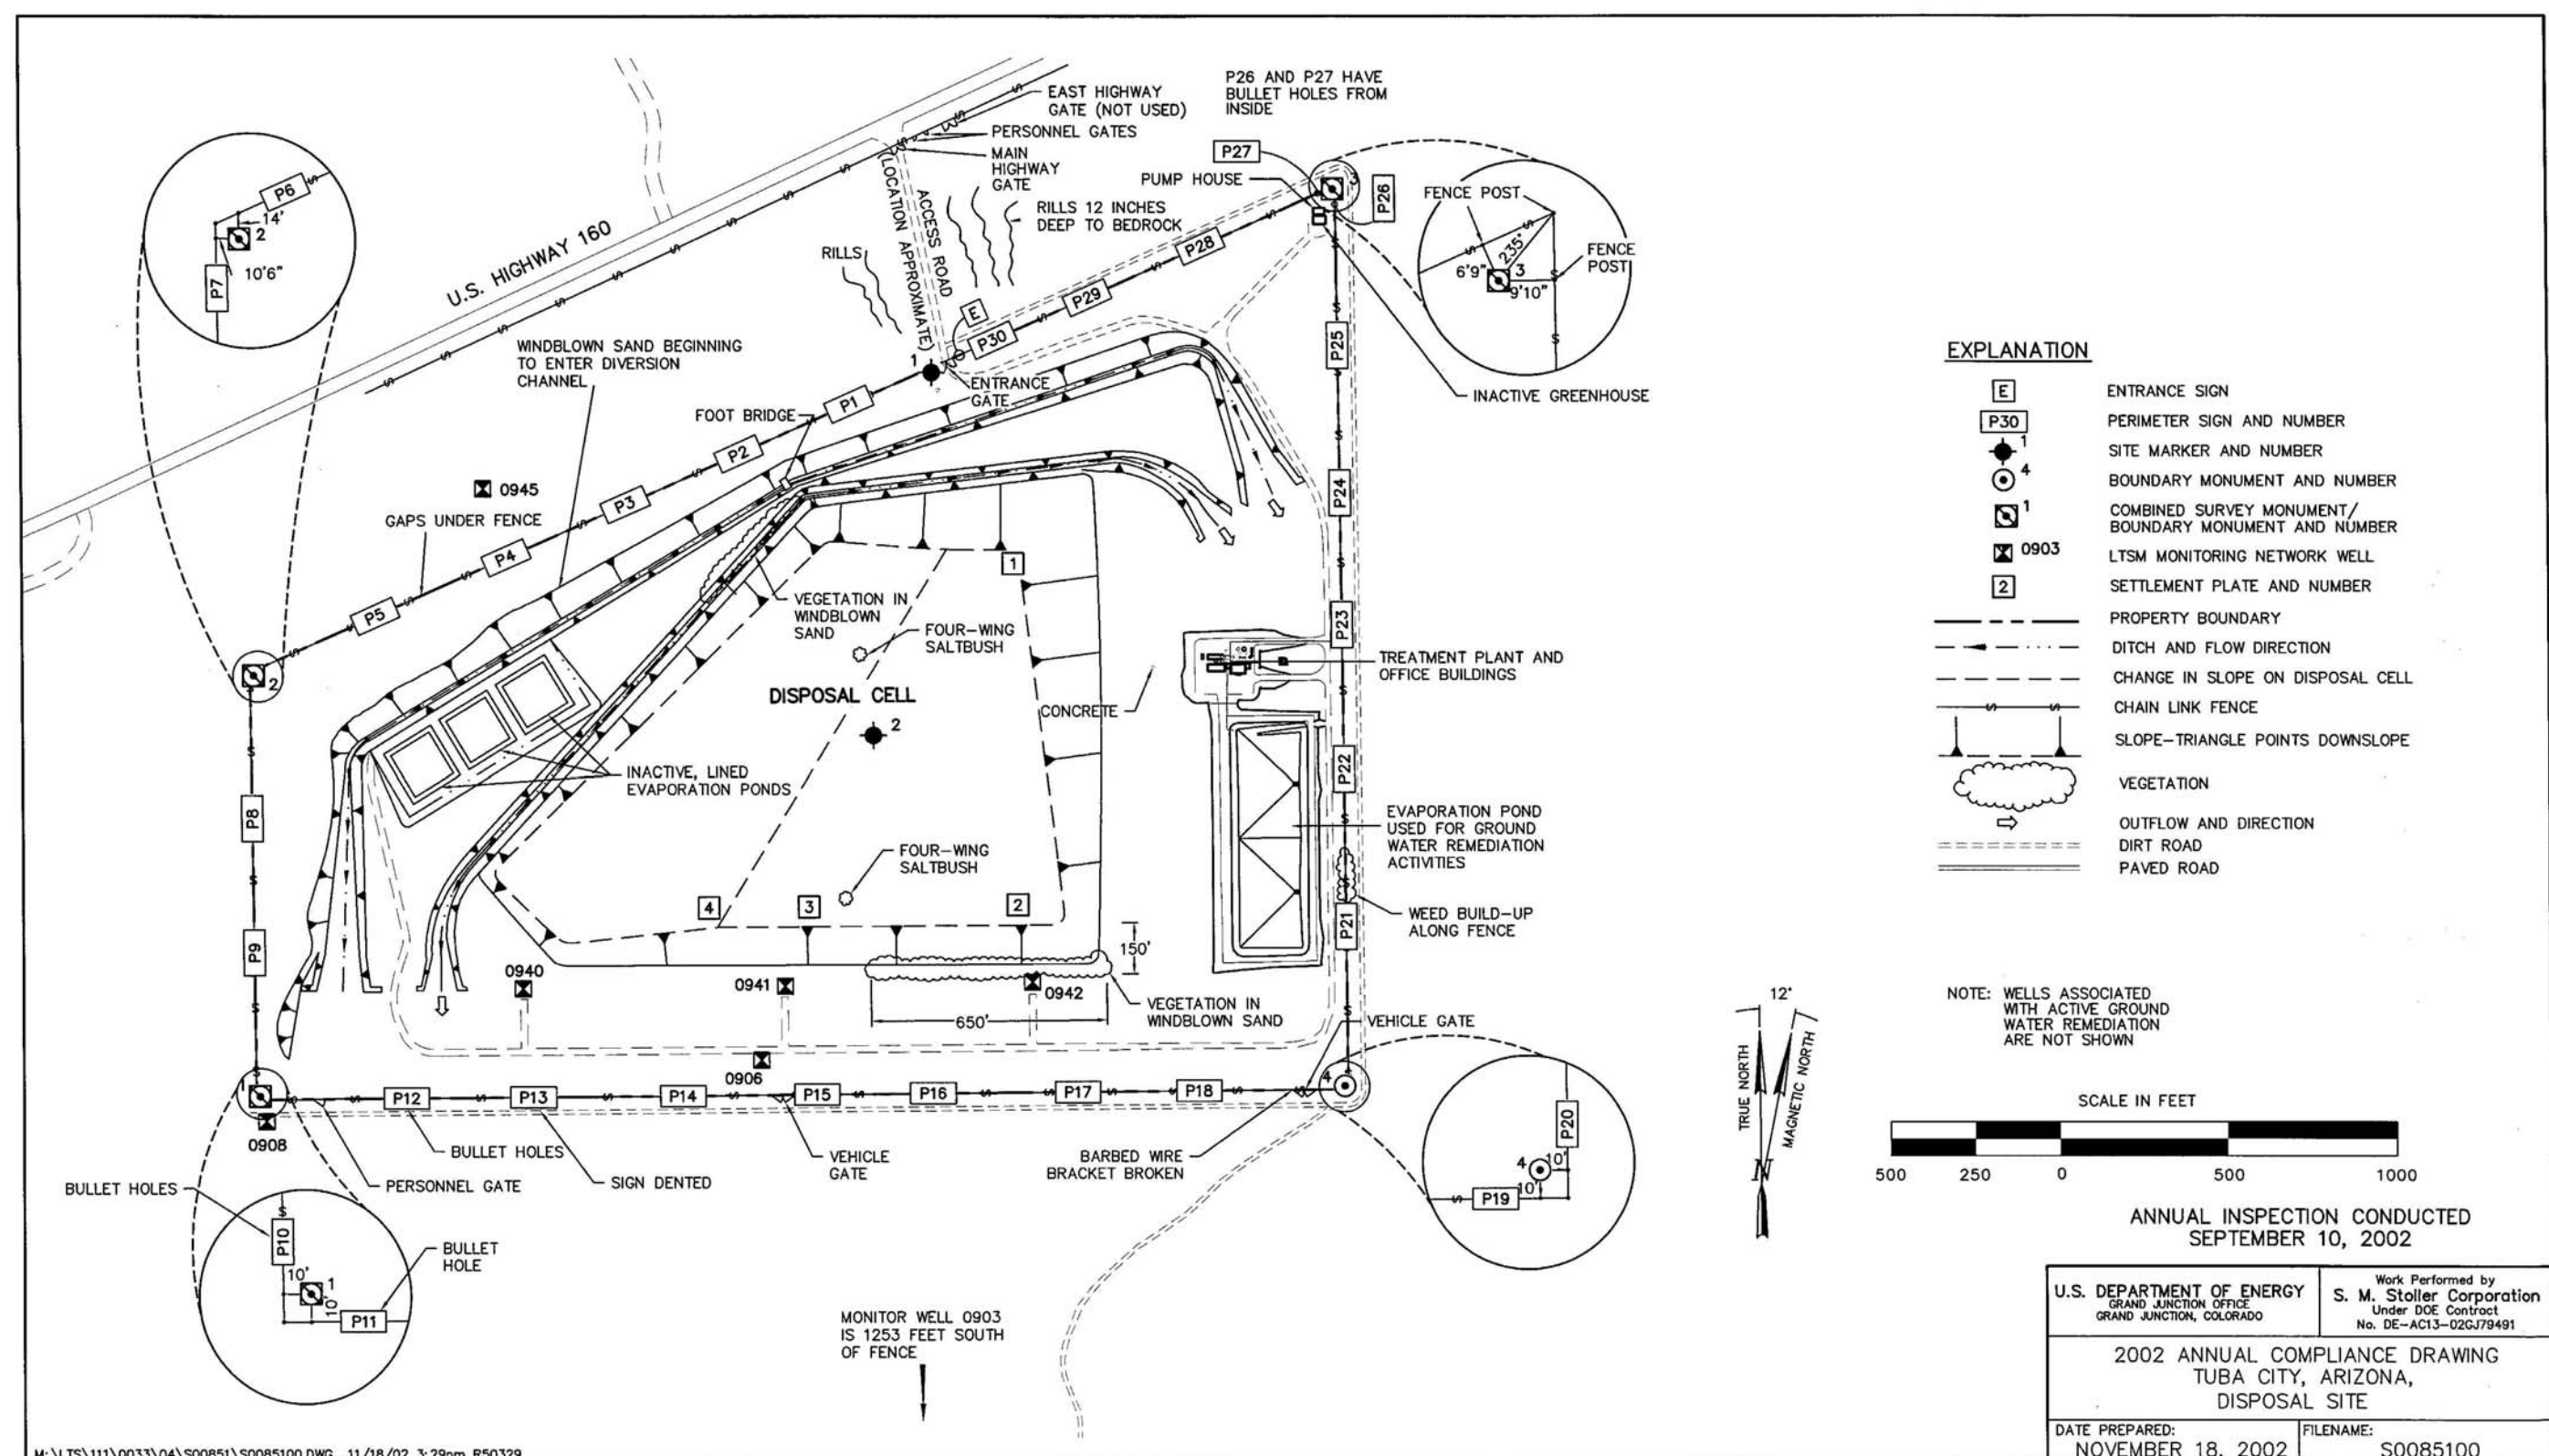
Figure 19-1. 2002 Annual Compliance Drawing for the Tuba City, Arizona, Disposal Site

Disposal Cell—The disposal cell is covered with riprap for erosion protection. The rock was in excellent condition. Inspectors discovered no evidence of slumping, settling, or instability on the top or side slopes of the disposal cell.

Patches of dead kochia and Russian thistle were seen on the south side slope and top slope of the cell. A few patches of these weeds were present on the west and north side slopes. The reduced quantity of annual weeds when compared with previous years was likely due to drought conditions during the 2002 growing season. Inspectors continue to monitor changes in plant cover with photographs, which are taken from selected vantage points on an annual basis.

- 19B During the past summer, woody plants on the cell, primarily four-wing saltbush, were cut and their stumps treated with herbicide. The removal effort was effective because only two small plants were noted growing on the cell.

- 19C Although annual accumulation is small, sand continues to accumulate on the south rock apron, where it fills interstices in the riprap. This has encouraged establishment of shrubs and perennial grasses in the rock apron. Neither the sand nor the plants appear to compromise the erosion protection. However, the Long-Term Performance Project continues to evaluate the long-term effect of these plants, particularly the deep-rooted plants, on the disposal cell and the rock apron.

- 19D Another ongoing issue at the site is tumbleweed (dead Russian thistle) and sand accumulation along the fence lines. Tumbleweeds tend to accumulate along the west and northeast portions of the perimeter fence, and sand tends to accumulate along the western fence line. At the time of the 2002 inspection, neither tumbleweed nor sand accumulation was considered significant enough to require maintenance.

Two rock-lined drainage channels are constructed on the north (upslope) side of the disposal cell. The outermost channel intercepts storm water and diverts it around the disposal cell to the south and east. The inner drainage channel, constructed at the toe of the north and northwest sides of the disposal cell, collects runoff from the disposal cell itself and diverts it to the south and east as well. Sand accumulation in the inner diversion channel and in the northwest segment of the outer diversion channel was unchanged since the 2001 inspection and does not interfere with the channels' drainage function.

The security fence around the site is chain link with three strands of barbed wire at the top. With one exception, the security fence was intact and in good condition at the time of the annual inspection. The bracket supporting the three strands of barbed wire at the west end of the entrance gate was broken and will be replaced.

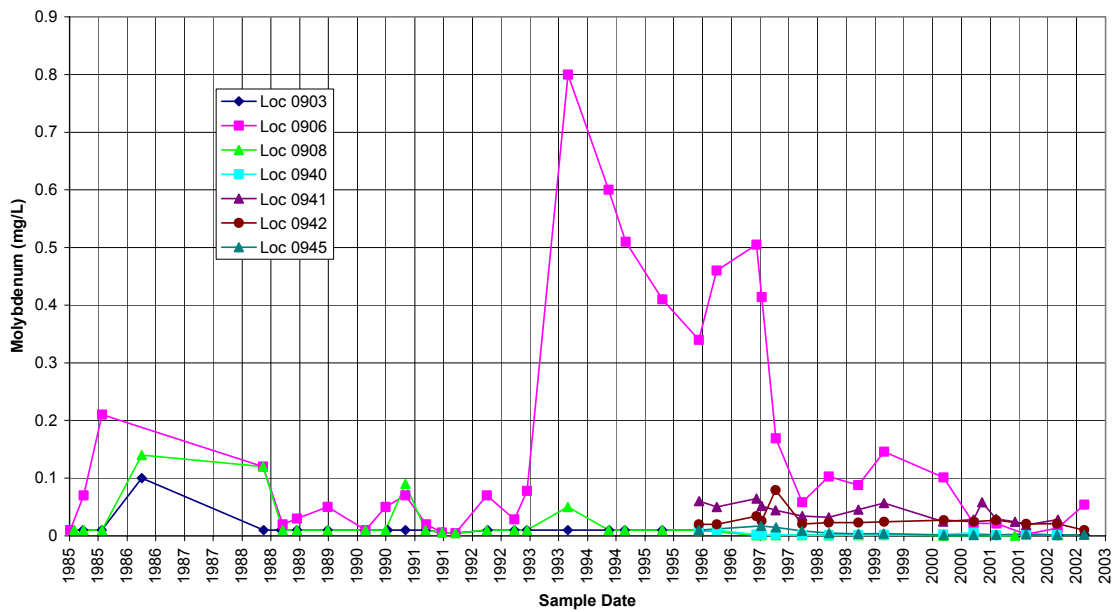
Figure 19–2. Time-Concentration Plots of Molybdenum in Ground Water at the Tuba City, Arizona, Disposal Site

Molybdenum concentrations did not exceed the 0.1 milligram per liter (mg/L) standard in samples from any well in 2002. Except at well 0906, molybdenum concentrations have not varied significantly in the last 15 years (Figure 19–2). Samples from well 0906 typically have had higher and more variable molybdenum concentrations than samples from other wells.

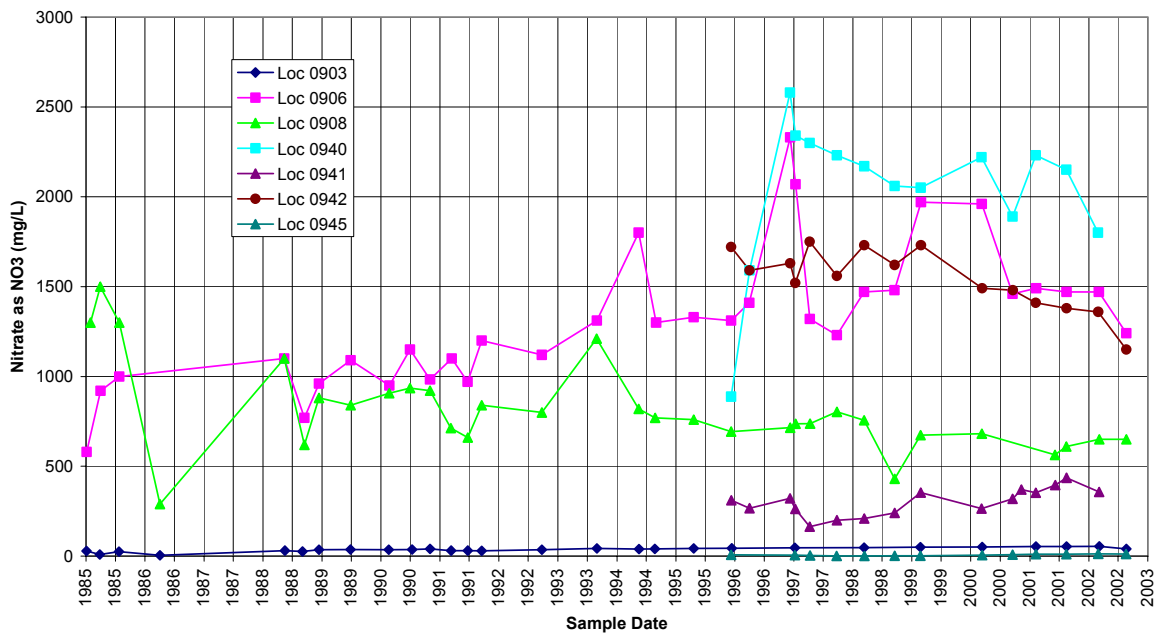
Figure 19–3. Time-Concentration Plots of Nitrate (as NO₃) in Ground Water at the Tuba City, Arizona, Disposal Site

In 2002, the concentration of nitrate (as NO₃) exceeded the 44 mg/L standard in samples from all monitor wells except well 0945, the background well. Between 2001 and 2002, no significant increases or decreases in concentrations were observed in samples from any well, although concentrations varied considerably—by more than two orders of magnitude—from well to well (Figure 19–3).

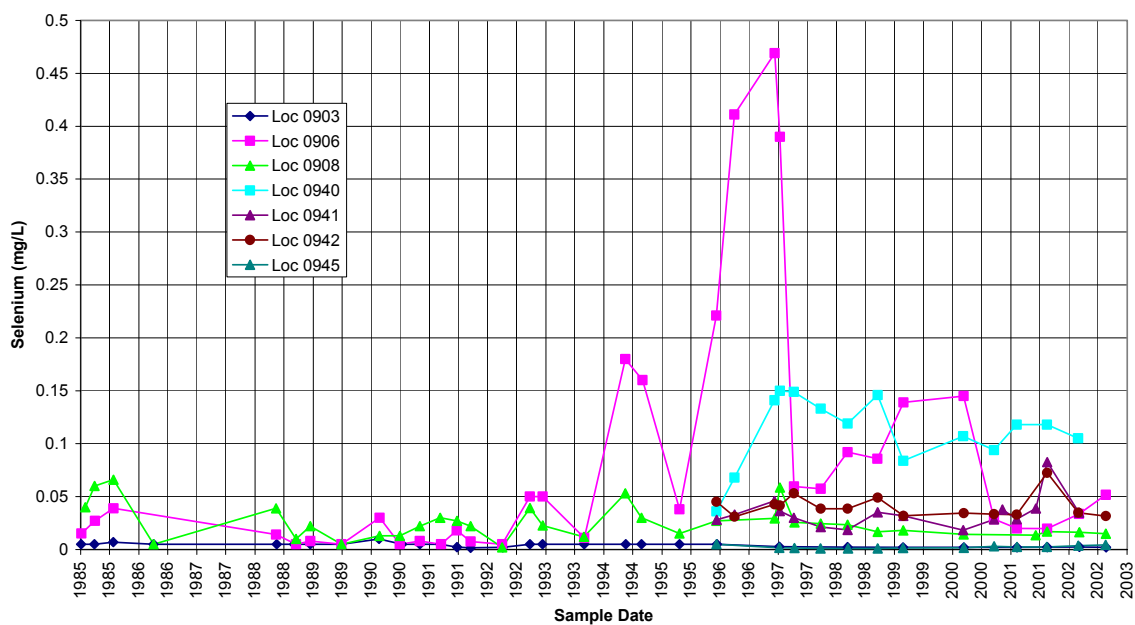
Figure 19-4. Time-Concentration Plots of Selenium in Ground Water at the Tuba City, Arizona, Disposal Site

Consistent with historical data, selenium concentrations exceeded the 0.01 mg/L standard in 2002 in samples from all wells except background well 0945 and off-site, downgradient well 0903. Selenium values have remained fairly consistent in samples from all wells except 0906 and 0940 (Figure 19–4).

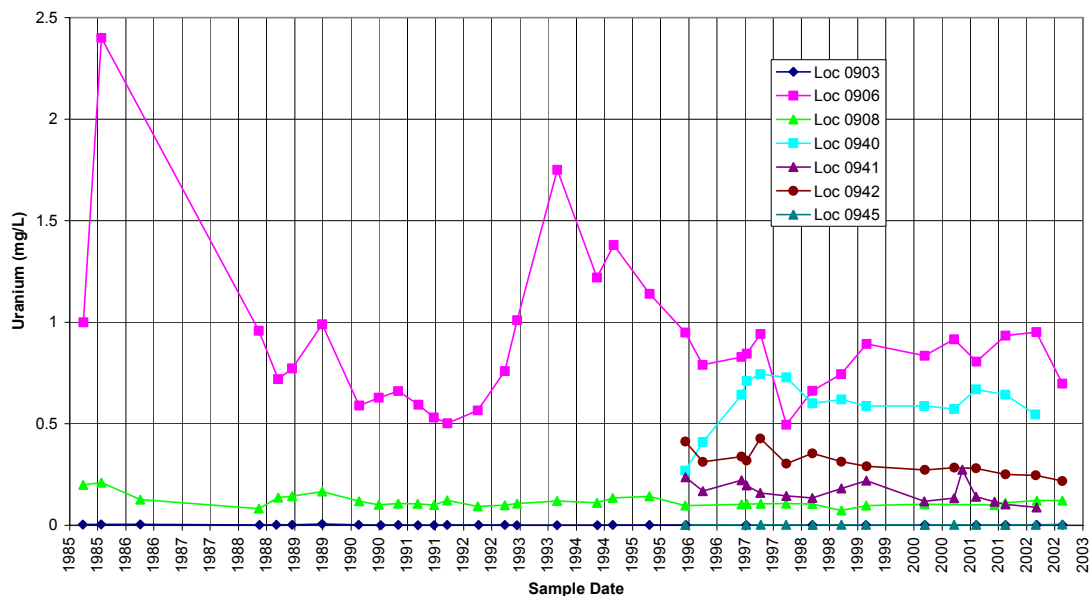
Figure 19-5. Time-Concentration Plots of Uranium in Ground Water at the Tuba City, Arizona, Disposal Site

Uranium concentrations exceeded the 0.044 mg/L standard in 2002 samples from all wells except background well 0945 and off-site, downgradient well 0903. Concentrations have remained fairly constant over time in samples from all wells except 0906 and 0940 (Figure 19–5).
